Monitoring Data Record

Project Title: <u>R-2231CB (US 220 Bypass)</u> COE Action ID: <u>199400590</u>
Stream Name: <u>UT to Big Mountain Creek (Site 6)</u> DWQ Number: <u>000874</u>
City, County and other Location Information: Montgomery County, US 220 Bypass (Station
268+00 LT.
Date Construction Completed: water was turned on 9/19/05
Monitoring Year: (2) of 5
Ecoregion: 8 digit HUC unit 03040203
USGS Quad Name and Coordinates:
Rosgen Classification:
Length of Project: <u>253'</u> Urban or Rural: <u>Rural</u> Watershed Size:
Monitoring DATA collected by: M. Green and J. Young Date: 7/17/08
Applicant Information:
Name: NCDOT Roadside Environmental Unit
Address: 1425 Rock Quarry Road Raleigh, NC 27610
Telephone Number: (919) 861-3772 Email address: mlgreen@dot.state.nc.us
Consultant Information:
Name:
Address:
Telephone Number: Email address:
Project Status: Complete

UT Big Mountain Creek (Site 6)

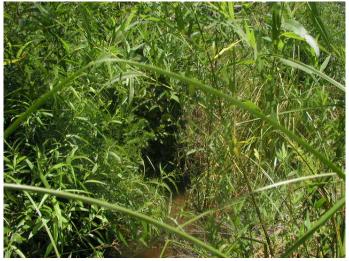
Photo Point #3 (Upstream)

The stream relocation is stabilized for the 2008 evaluation. Some beaver activity was noted upstream of Photo Point #3. NCDOT will continue to monitor this stream relocation.

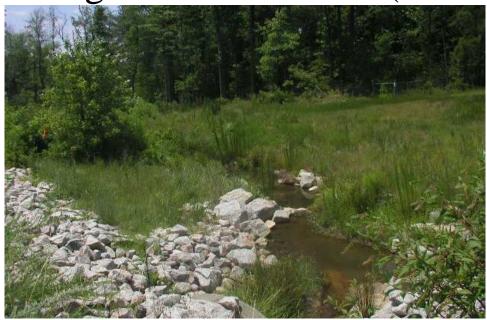
Overview of Site Looking Downstream
